CULEBRA

COMMUNITY WATERSHED ACTION PLAN FOR WATER QUALITY AND CORAL REEFS

PREPARED FOR
NOAA CORAL REEF CONSERVATION PROGRAM
PUERTO RICO DRNA
CULEBRA OFFICE OF THE MAYOR

PREPARED BY
Paul Sturm
Ridge to Reefs

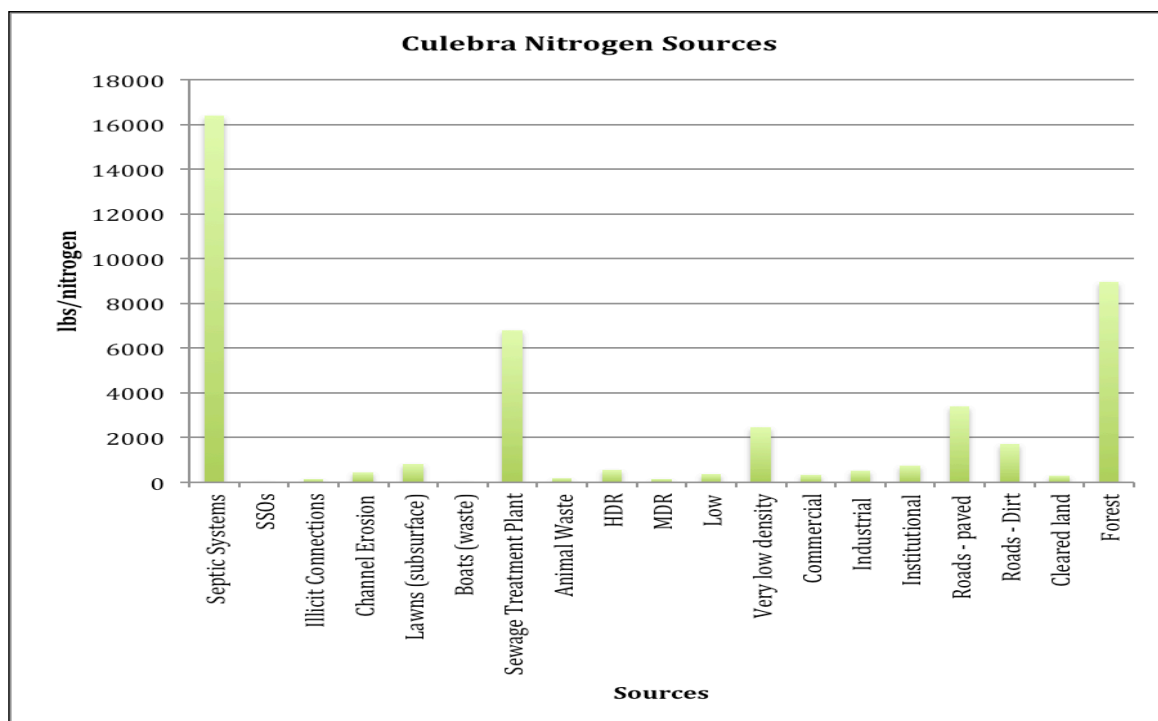
Figure 4. Nitrogen Source Estimates in Culebra using the WTM (HDR and MDR refer to High and Medium Density development) (Sturm et. al, 2014)

Figures 4 and 5 illustrate the sources of nitrogen and sediment in the watershed based on the model output. Septic systems (including direct sewage discharges to Ensenada Honda and the Lobina channel) are the largest source of nitrogen in the watershed, followed by forested areas and the sewage treatment plant. Other sources of note are paved roads, dirt roads and very low-density development. For sediment the major sources include dirt roads, forested areas, channel erosion, paved roads and cleared roads. It is important to note that on a per acre basis forest/fields (63% of the land use of Culebra) produces the least pollution of any land use, so few strategies are available to achieve further reduction – though where coastal lagoons are located they often intercept water from diverse land uses and improve water quality.

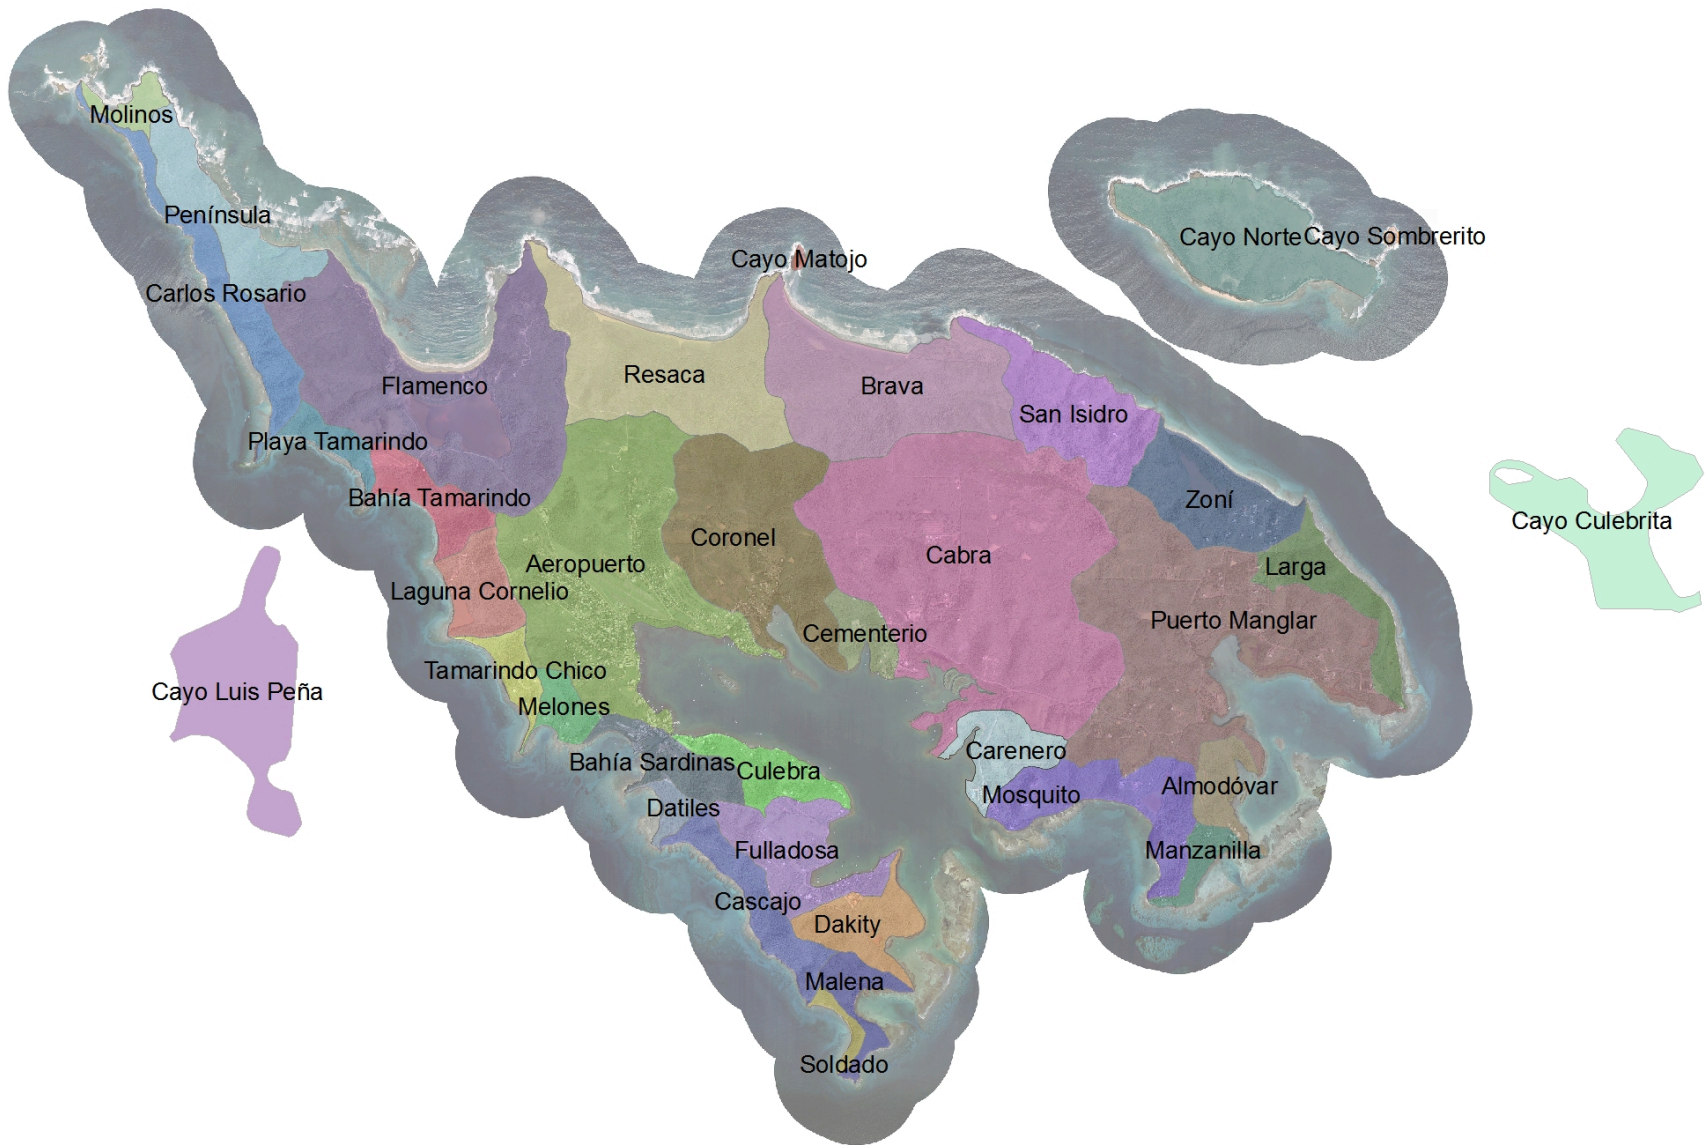
Figure 13. Culebra Subwatersheds

Culebra is approximately 11.6 square miles and to heighten our focus on the resources in different areas of Culebra we have broken the island into 37 subwatersheds (Figure 13). This helps highlight specific management efforts needed in specific subwatersheds as well as identify the existing and future threats and stressors to these systems.

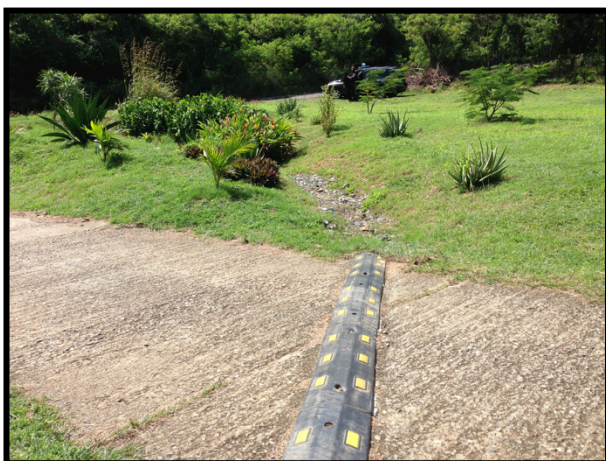
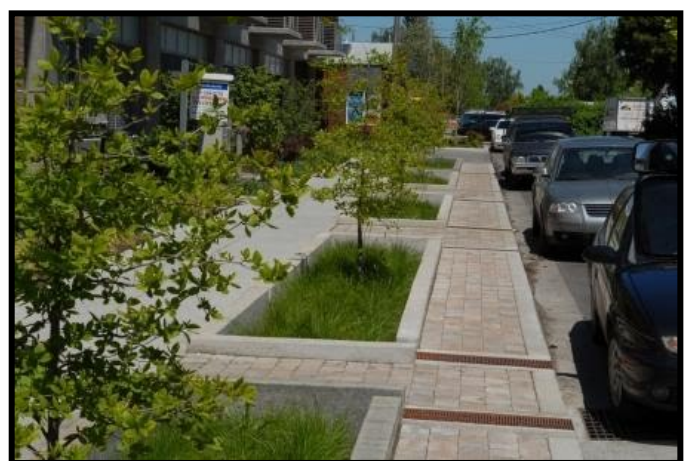
Figure 16. Rain garden from St. Croix and streetscape biofilters from Santa Monica, CA

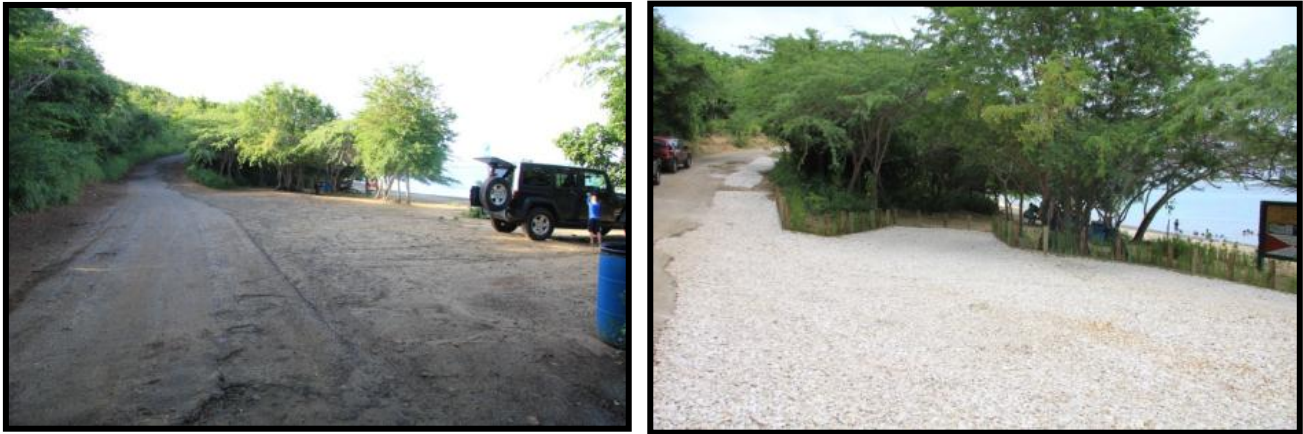
Figure 17. Before and after stabilization at Tamarindo Beach in Culebra

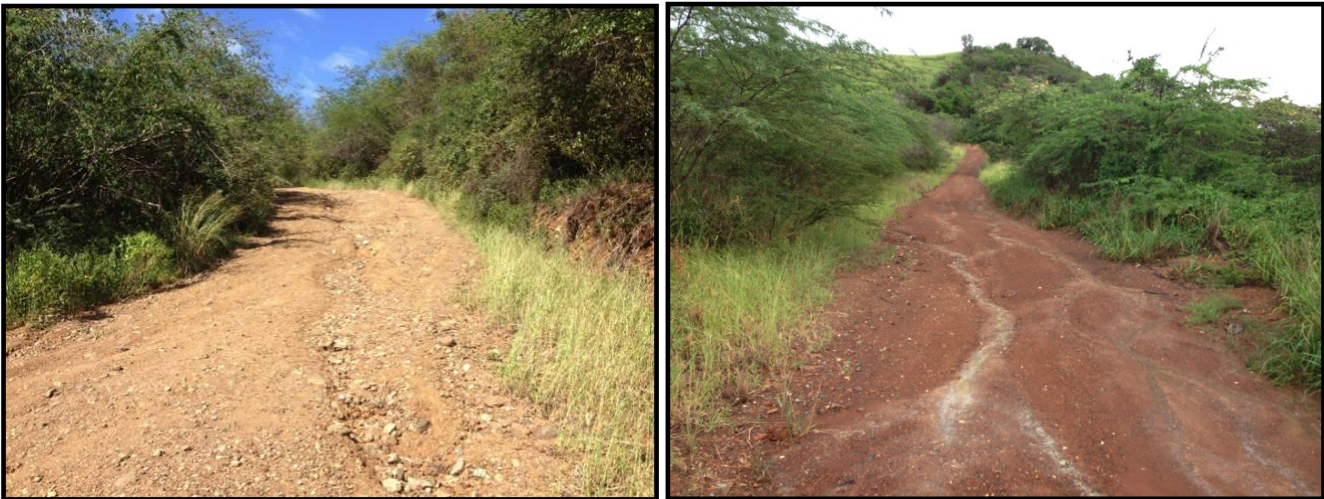
Figure 18. Dirt roads as a source of sediment (note the surface runoff over the roads creating erosion and resulting in fine sediment losses)

Stabilization of bare soils (Figure 18) involves the rapid re-stabilization of vegetation and generally a transition to more native and stable forms of vegetation. One effective way to re-establish vegetation in an area is to utilize hydroseeding followed by watering to rapidly transition to a more stable vegetated system where runoff is reduced. Dirt roads are stabilized using methods to remove water from the road and reduce erosion. These include concrete or dirt cross-swales, check dams and sediment traps. The recommendations for dirt road and bare soil stabilization are found in Table 5, maps are found toward the end of the section in Figures 23 and 24, and a dirt road layer created for the island is shown in Appendix A-5.

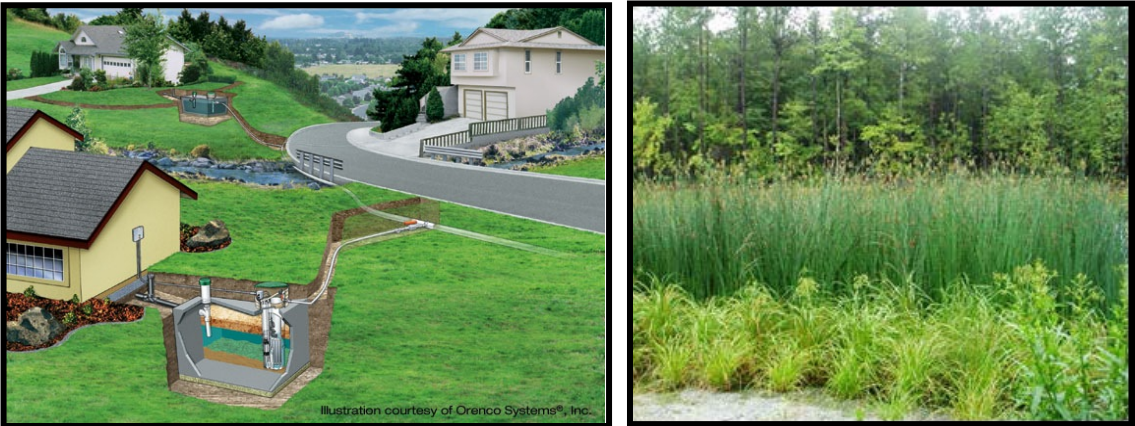
Figure 19. Pump and treat system effluent is pumped from homes to a constructed wetland or landscaped area

wetland such as is shown in the figure. These efforts should be focused at the WWTP (that historically used wetlands to treat the effluent) and at hotels and small communities on septic systems that cannot be easily connected to the WWTP.

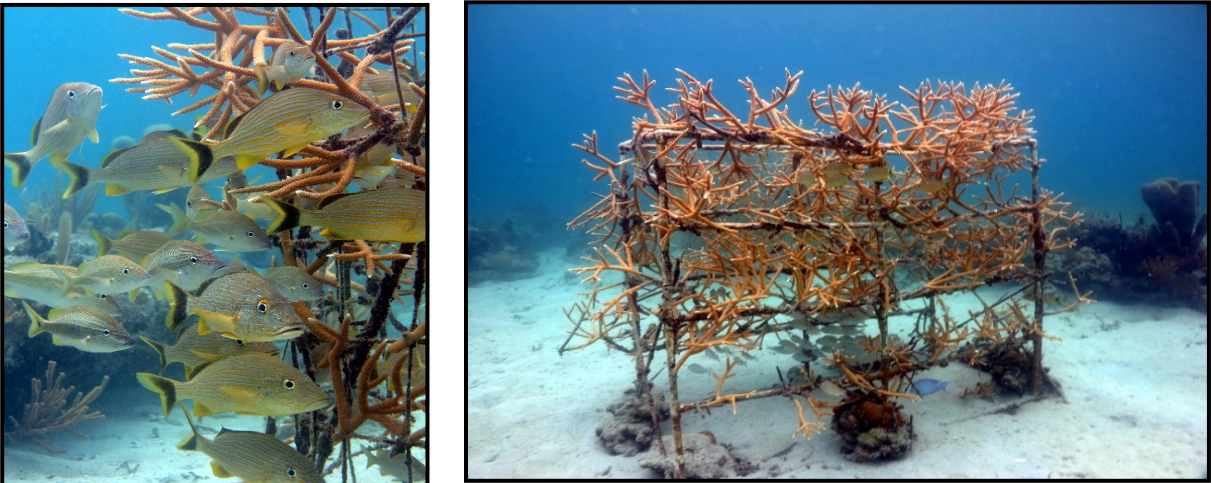
Figure 20. Coral restoration efforts in Tamarindo (Photo credit: CESAM)

Coral restoration involves the propagation of corals, in this case Staghorn coral (*Acropora cervicornis*) (Figure 20), and to a lesser extent other species including Elkhorn coral (*Acropora palmata*). These species have been decimated in the Caribbean - over the last 30 years there has been an 80 – 90% decline. Tamarindo Beach and Punto Soldado are two areas in Culebra where there have been restoration efforts. The goal of coral restoration efforts and out planting of corals has been to re-establish *Acropora* populations in the area. The community project of Coral Reef Rehabilitation and Aquaculture began in 2003 and has been led by the Society of Marine Environment (SAM) and Coralatians in collaboration with the University of Puerto Rico Center for Applied Tropical Ecology and Conservation (CATEC). Subwatershed restoration efforts should also be implemented to protect these important coral propagation areas that also contain coral reefs that are being restored and that are in relatively good condition.

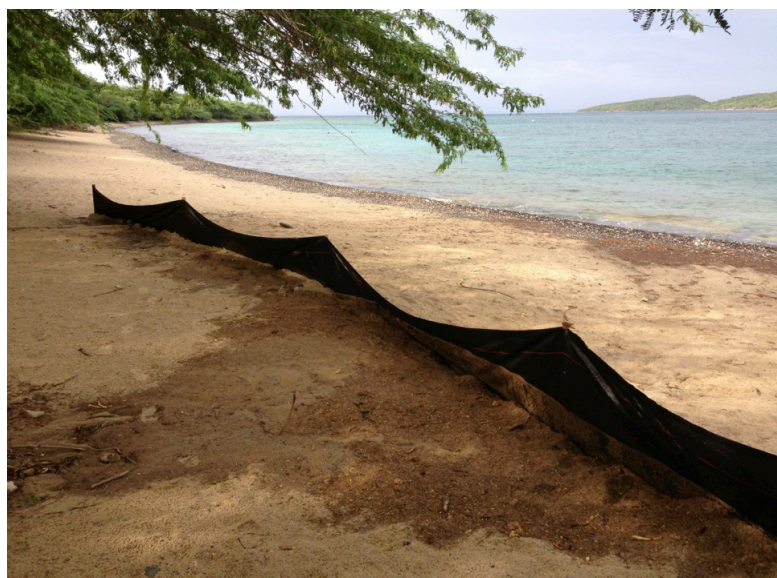
Figure 21. Silt fence at the Tamarindo restoration holding back sediment from nearshore waters from an upland dirt parking lot and restoration project
