Guánica Bay Watershed Management Plan

A Pilot Project for Watershed Planning in Puerto Rico

10/12/08

Center for Watershed Protection
8390 Main St, 2nd Floor
Ellicott City, MD 21043 USA

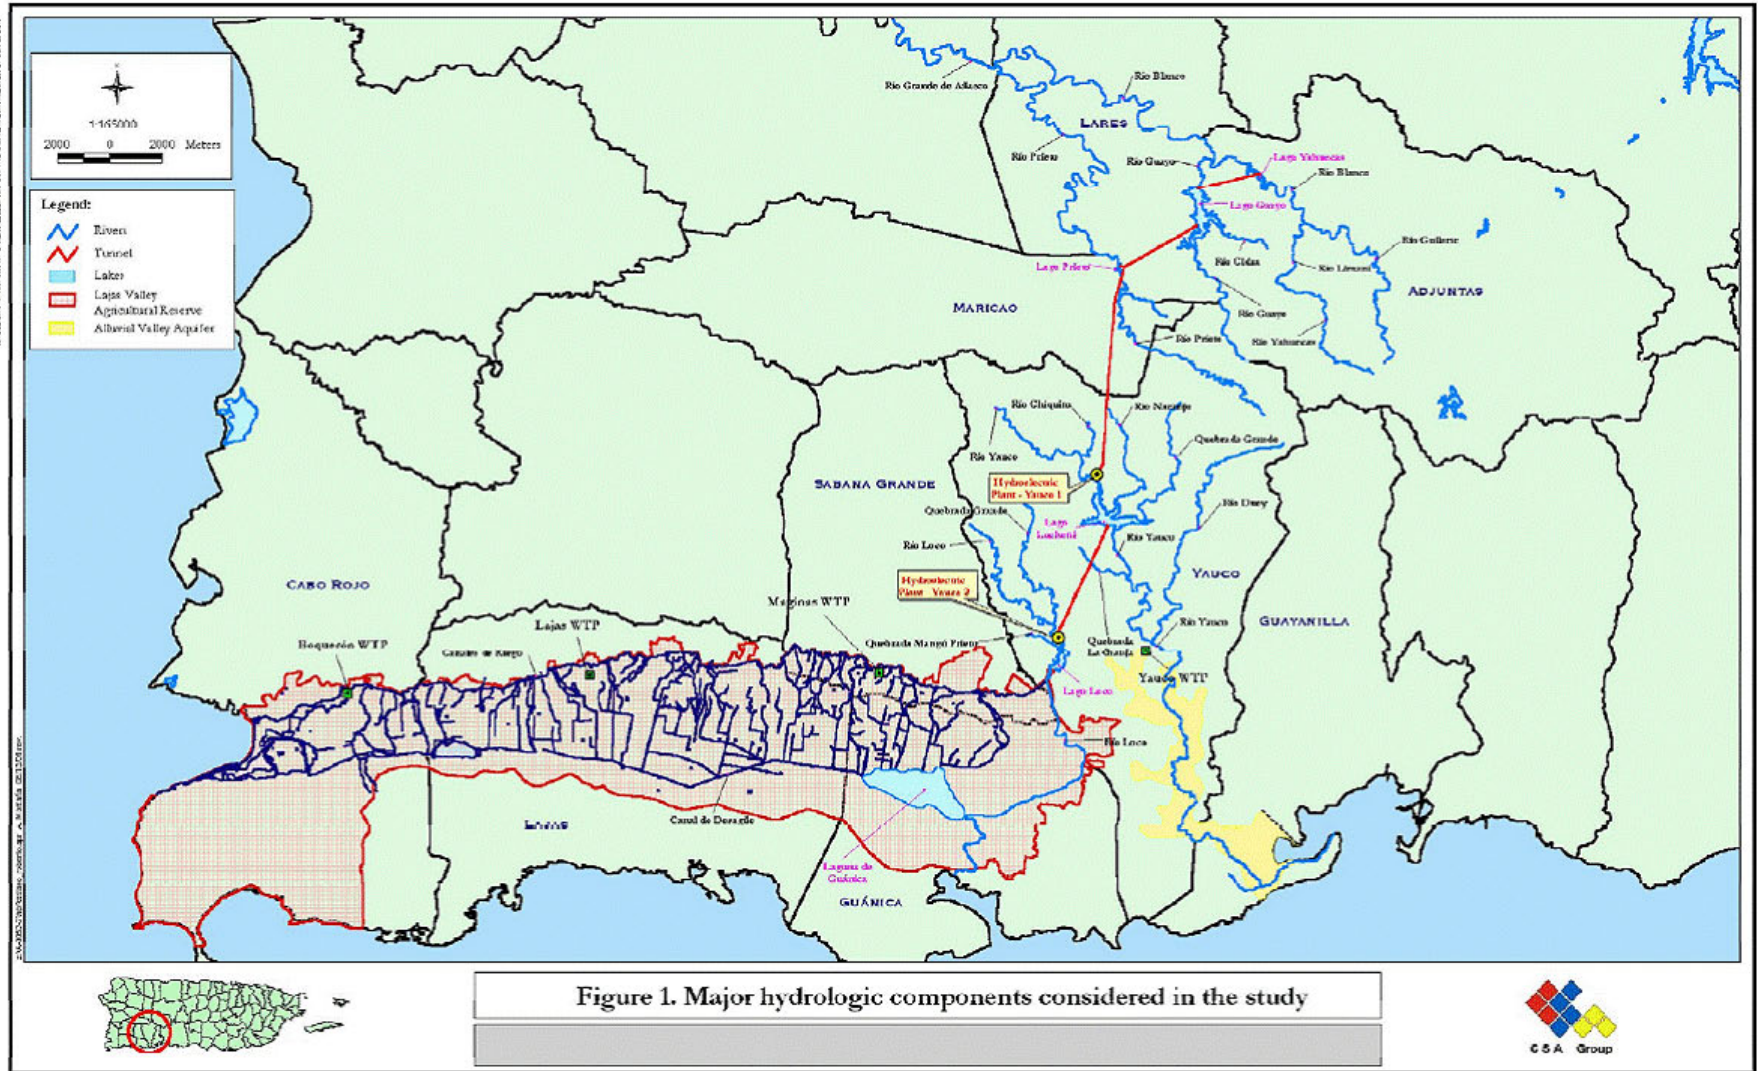
Figure 1. Major hydrologic components considered in the study

Figure 1: Shows the Guánica Bay watershed, which is drained to the north by the drainage basins of Lakes Yabuecas, Guayo, Prieto, Lucchetti, and Loco as a result of the Southwest Puerto Rico Project. To the south, the study area includes the drainage areas of Río Loco. Finally, the study area includes roughly half of the Lajas Valley, including historic Laguna de Guánica (Guánica Lagoon) and the Lajas Irrigation Canal within the Valle de Lajas (Lajas Valley) Agricultural Reserve. (Map from Ortiz-Zayas & Terrasa-Soler, 2001)

The Guánica Bay watershed is a highly manipulated watershed. It has been artificially increased in drainage area by a series of interbasin or inter-watershed water transfers, five reservoirs and two hydroelectric plants (Yauco 1 and 2) known as the Southwest Water Project (Figure 1). This project, operated by Puerto Rico Electric Power Authority (PREPA), was completed in order to increase and regulate potable water from the high elevation watersheds of the central cordillera (mountain region) for use by the local populations in Yauco, Guánica and the Lajas Valley for irrigation of crops and flood control. So while Guánica Bay receives water directly only by the Rio Loco (“Crazy River”), the actual total drainage area encompasses much more than just the Loco watershed. This includes the five smaller basins and associated reservoirs: Lago Yahuecas, Lago Guayo, Lago Prieto, Lago Lucchetti, and Lago Loco. Guánica Bay is essentially drained by both the Rio Loco which receives flow from the four reservoirs north and upstream of it as well as by historic Guánica lagoon, all of which we refer to here as the Guánica Bay/ Rio Loco (GB/RL) watershed. (Ortiz-Zayas & Terrasa-Soler, 2001).

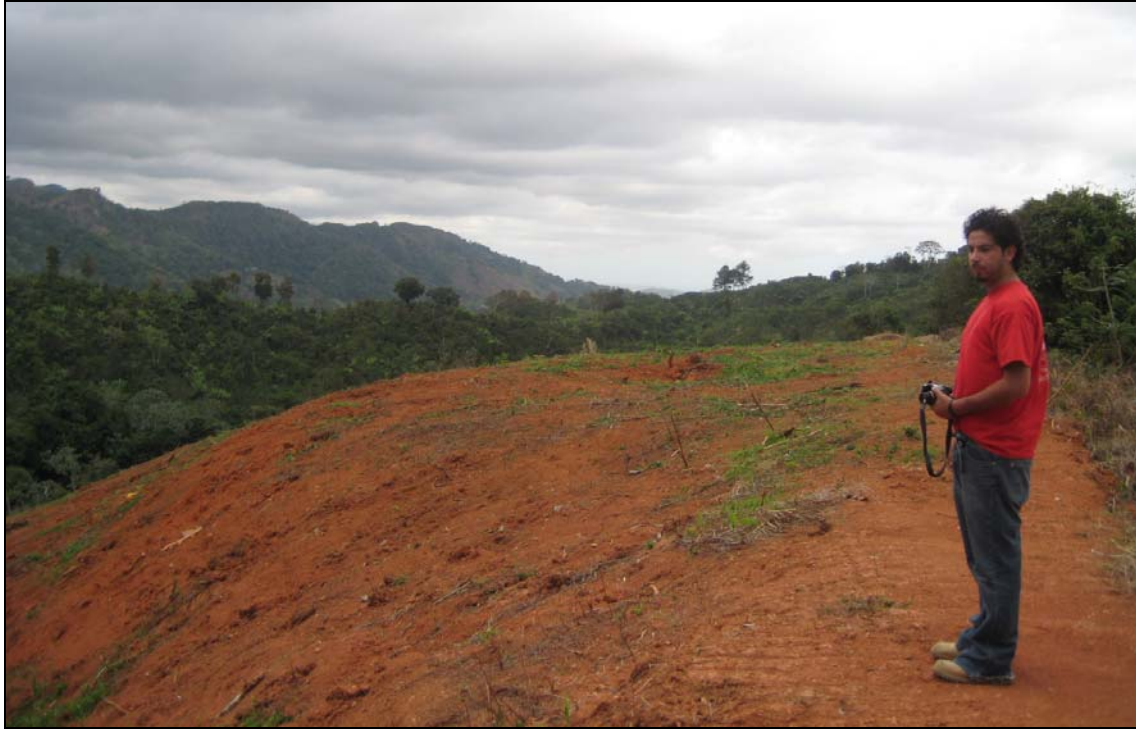
Figure 2. Typical clearing associated with sun grown coffee plantations

Field investigations in the high elevation agricultural areas near reservoir (“Lago”) Lucchetti and the Rio Loco watersheds revealed clearing for coffee and other agricultural crops, including bananas, with very little evidence of conservation practices. Mass clearing, poor soils (Humatas Clay) and runoff associated with roads has resulted in numerous areas with completely exposed soils with very limited natural re-vegetation due to the high clay content and low fertility of the soils. Promotion of sun grown coffee over historically grown shade grown coffee at the very least accelerates sediment transport during the crop establishment phase. There is an estimated 3.5 times more erosion associated with sun grown coffee than shade grown coffee over the first several years after establishment (Hartemink, 2006).

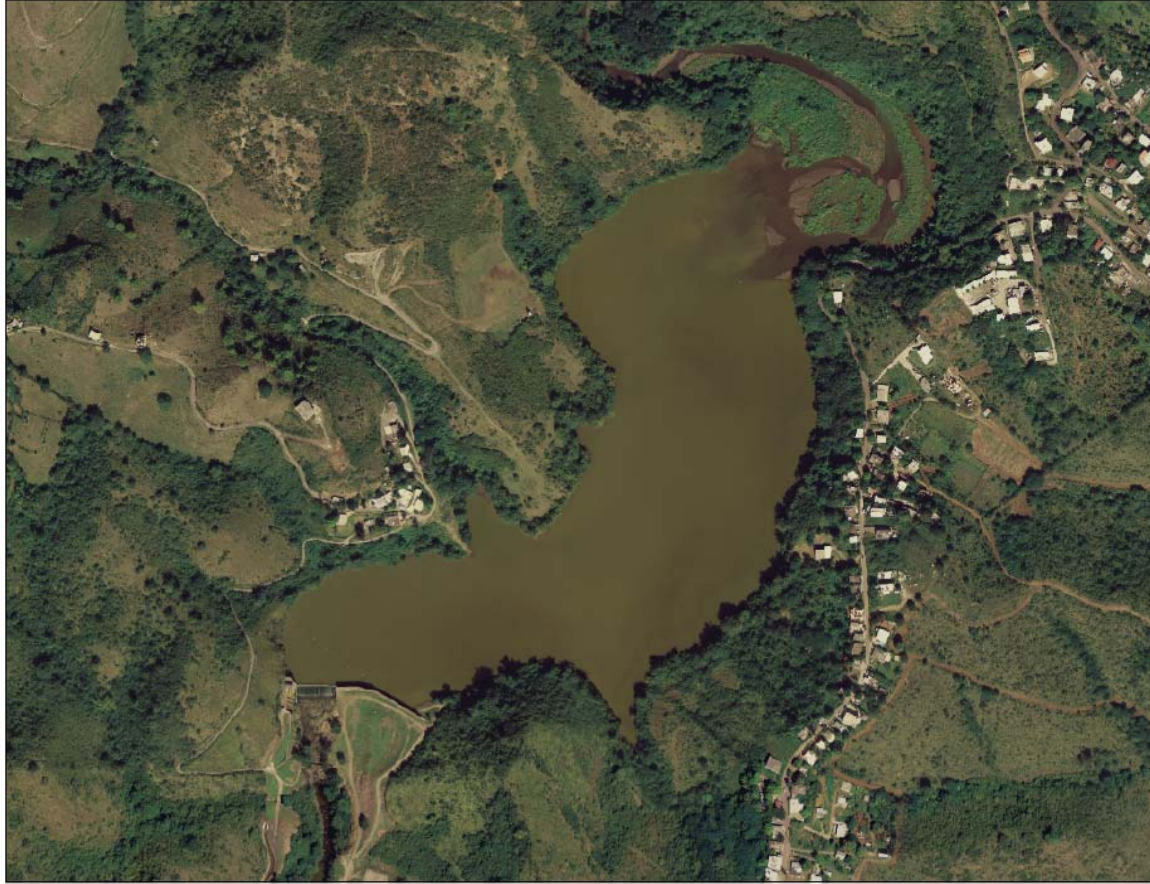
Figure 3. Snapshot of sediment accumulation and flow through Loco Reservoir.

A review of orthophotography with DRNA biologists at Guanica forest reserve clearly showed that sediment was passing through the Rio Loco Reservoir (Figure 3) through the watershed and into Guánica Bay. Even closer inspection revealed at least some of the sediment laden water was being discharged from the pump/flow house draining from Lucchetti Reservoir into Loco (Figure 4). The reddish clay colored water was clearly visible in the Rio Loco below the dam and extending down to the Guánica Bay and out to the near shore coral reefs.

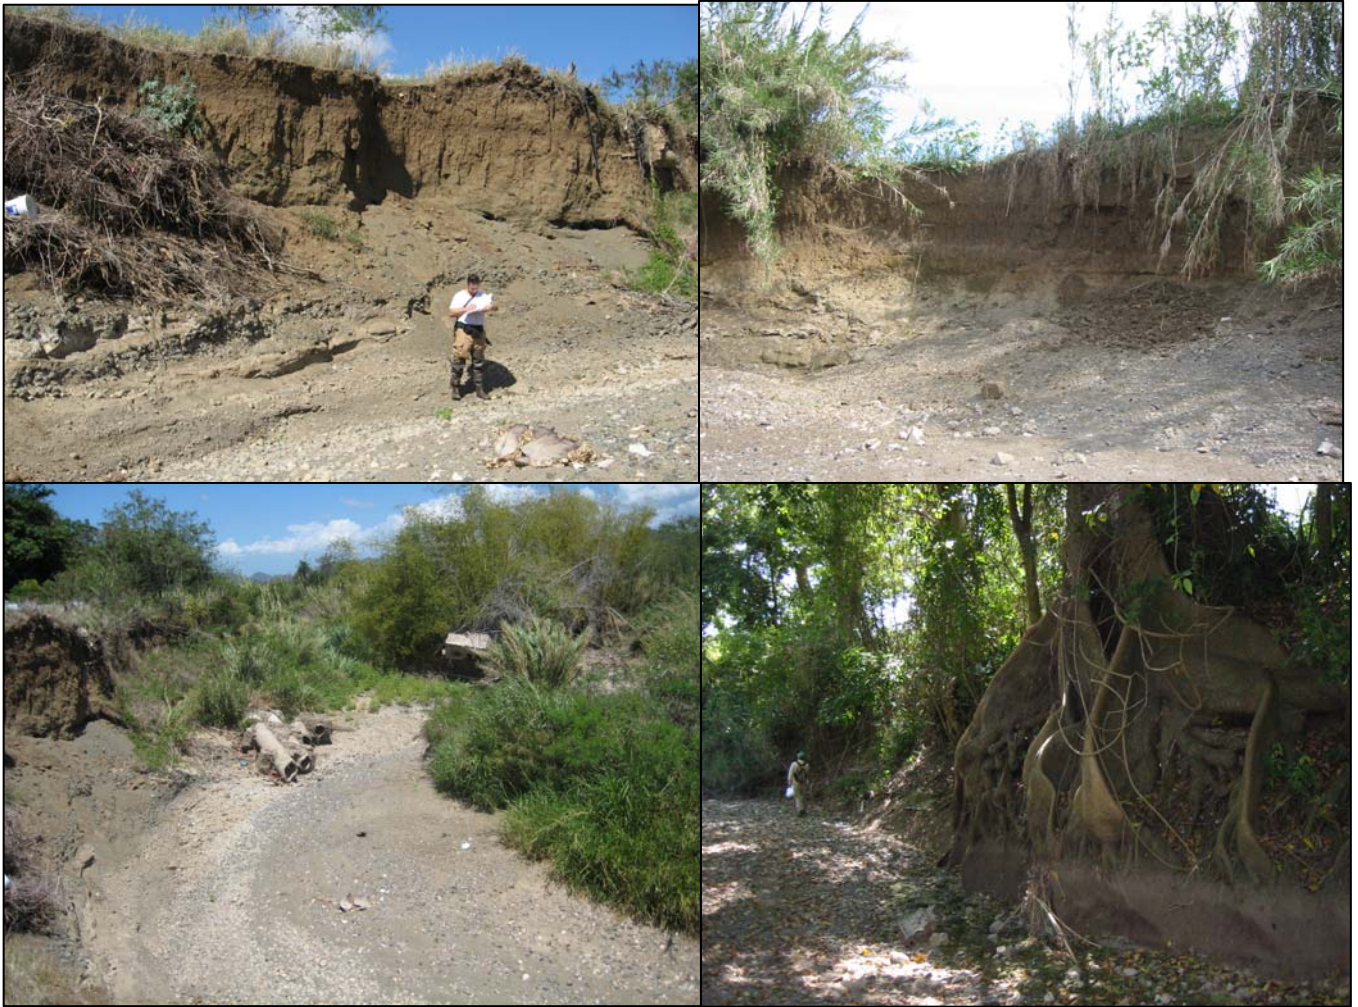
Figure 5. Channel erosion in the Rio Loco due in part to old irrigation infrastructure, invasive species and the loss of Guánica Lagoon. The picture on the lower right shows the potential role of trees in this ecosystem to help to fortify streambanks and reduce erosion

Channel erosion on the mainstem of Rio Loco was clearly another major issue in the watershed as documented in the stream channel assessments. Severe erosion was associated with areas that lacked mature riparian trees, particularly those areas that contained non-native species that seemed to exacerbate erosion as well as areas with historic irrigation infrastructure which created downstream scour (Figure 5). These low head dams, concrete footers, and other structures continue to act as strainers and constrictions in the channel causing debris to become lodged and changes in erosive forces to destabilize banks, increasing channel erosion, bed scour and sediment transport. Both Warne et. al. (2004) and Clark and Wilcox (2000) noted the continued importance of transport of historically deposited valley sediments and its likely impact on coral reef systems.

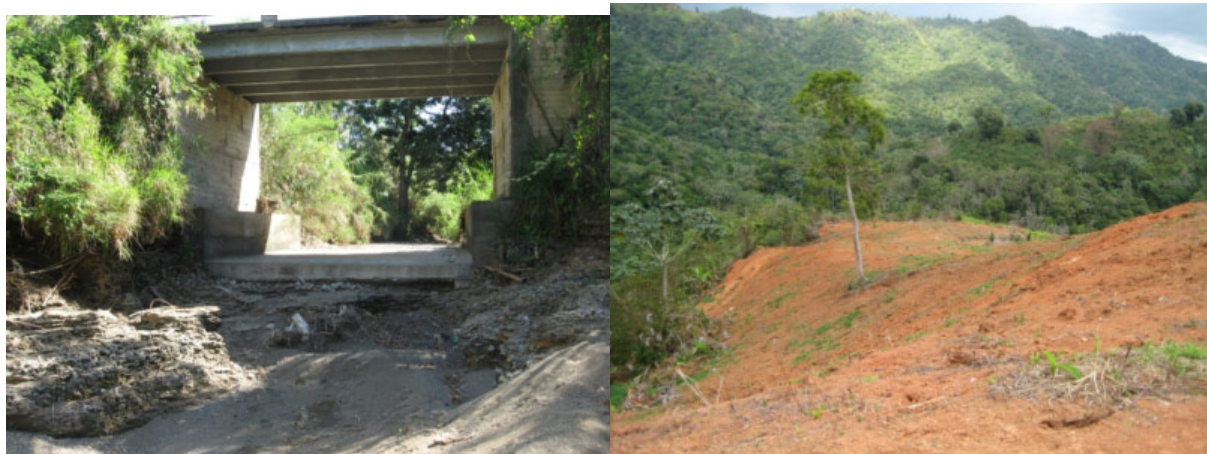
Figure 6. Left: Rio Loco river culvert, completely dry in April 2008; Right: Example of typical land clearing in upper watershed for coffee cultivation, without soil stabilization.

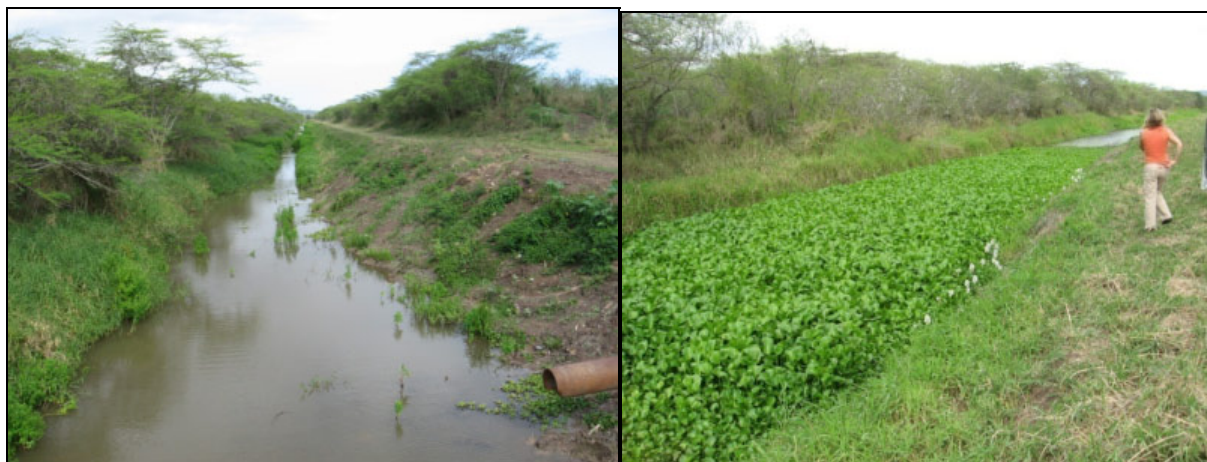
Figure 7. Lajas Valley Canal irrigation channel. Note: canal surface water immediately around outfall draining agricultural and pasture fields is replete with aquatic vegetation.

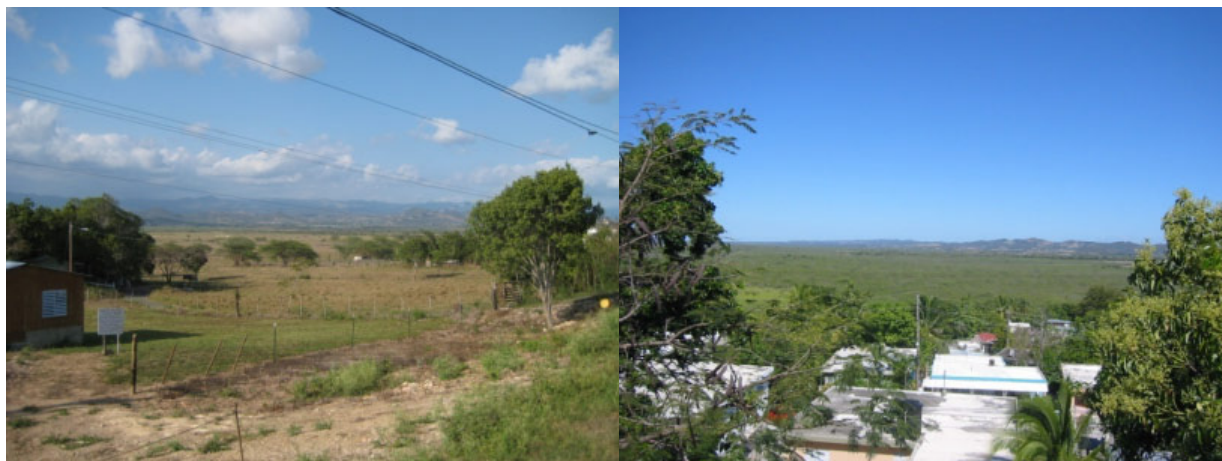
Figure 8. Section of the Lajas valley (left); Historic Guánica lagoon in the distance (right).

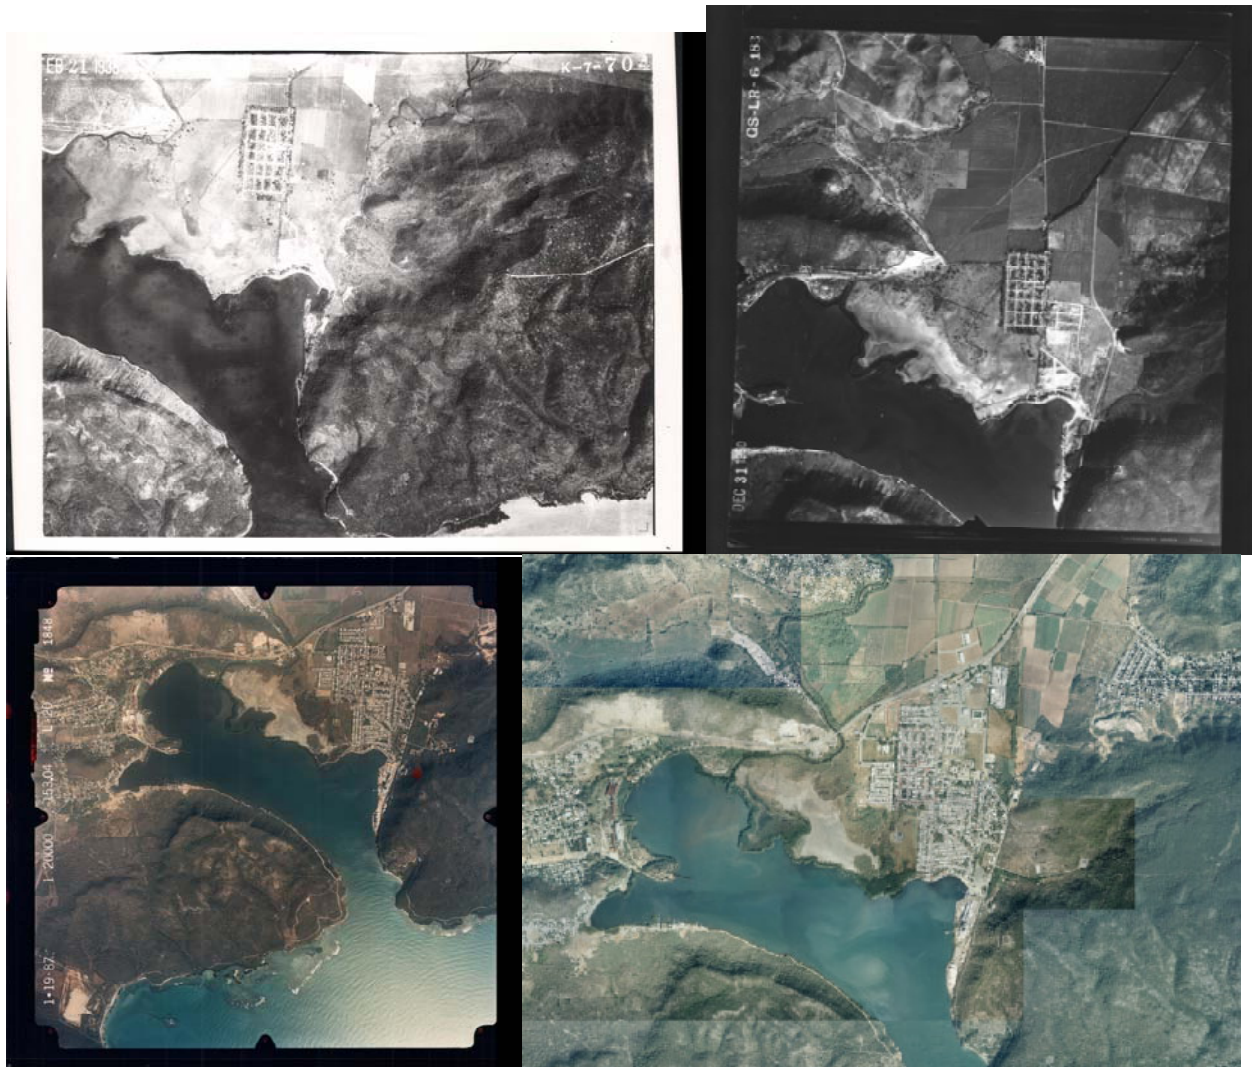
Figure 9: Aerial photographs of Guánica Bay and the near shore area taken in 1936 (top left), in 1950 (top right) in 1987 (bottom left) and again in 1996 (bottom right). Notice the significant increase in urbanization along northeastern shore nearer to mouth of the Bay sometime after 1950.

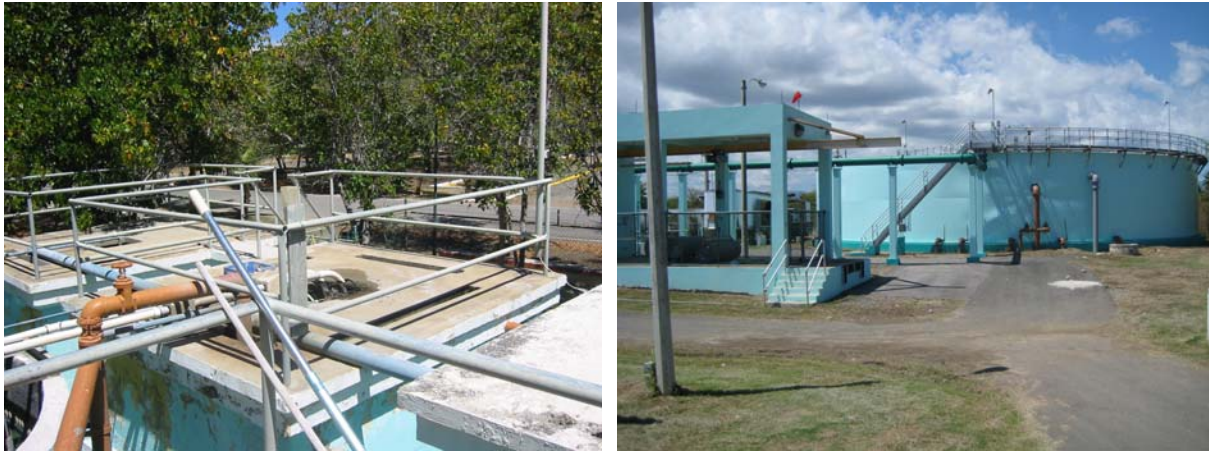
Figure 10. Small 3000 gpd sewage treatment plant at Cana Gorda Beach (left), one750,000 gallon treatment tank within Guánica waste water treatment plant.

Two treatment plants (shown in Figure 10) are located in tidal areas in the watershed. A summary of their capacity and return flow are located in Table 4. Guánica Sewage Treatment Plant (STP) which currently receives 460,000 gallons per day from Guánica proper and but is capable of accepting 750,000 gallons per day for secondary treatment (Guanica STP operators personal communication, 2007). This same treatment plant has been recently upgraded with three additional treatment tanks with a total additional capacity of 2 million gallon per day of secondary-advanced treatment as part of additional proposed development in Guánica. The second much smaller treatment plant is located at Cana Gorda Beach and handles about 3000 gallons per day but has a treatment regime dictated by use of the public beach and associated facilities which is of course seasonal.

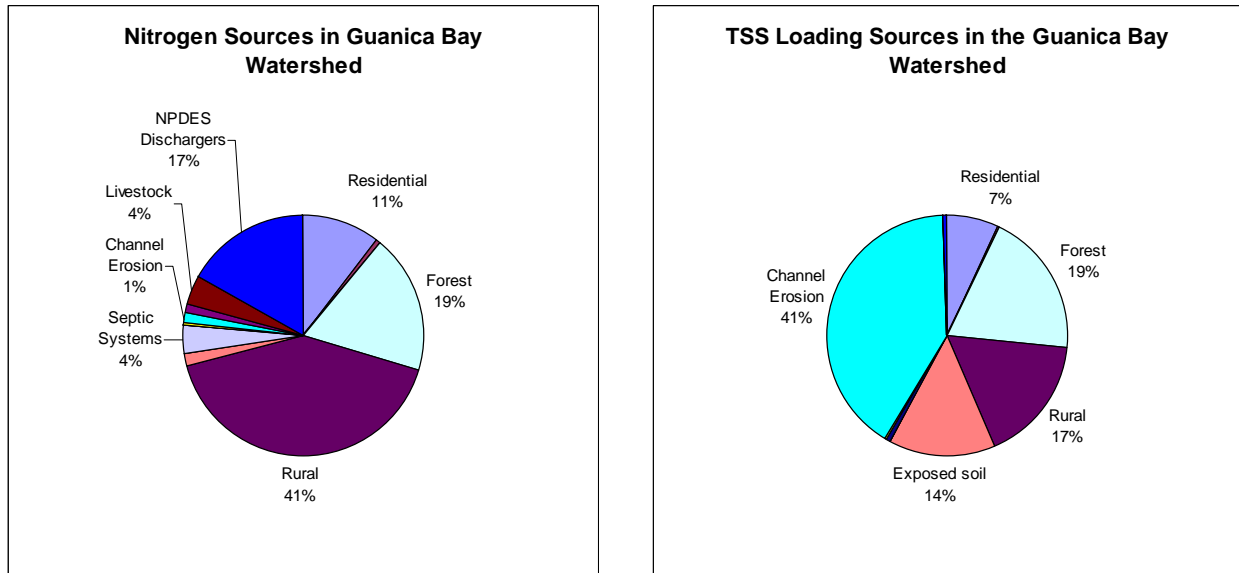
Figure IV-1. Nitrogen and Sediment Sources in the Guanica Bay/ Rio Loco Watershed

- the remaining sources of nitrogen loads rural land (41%) and forest land (19%) generally have to travel some distance within the streams and Rio Loco itself – this humid tropical system is effective at processing nitrogen particularly during baseflow conditions (Ortiz-Zayas, 2006). So a portion of the loads from these sources are likely reduced through in-stream denitrification before reaching the coastal waters.
