# Management Action Plan for the Guánica State Forest Marine Extension

**Prepared by:**  
Protectores de Cuencas Inc.

**Prepared for:**  
NOAA Coral Reef Conservation Program

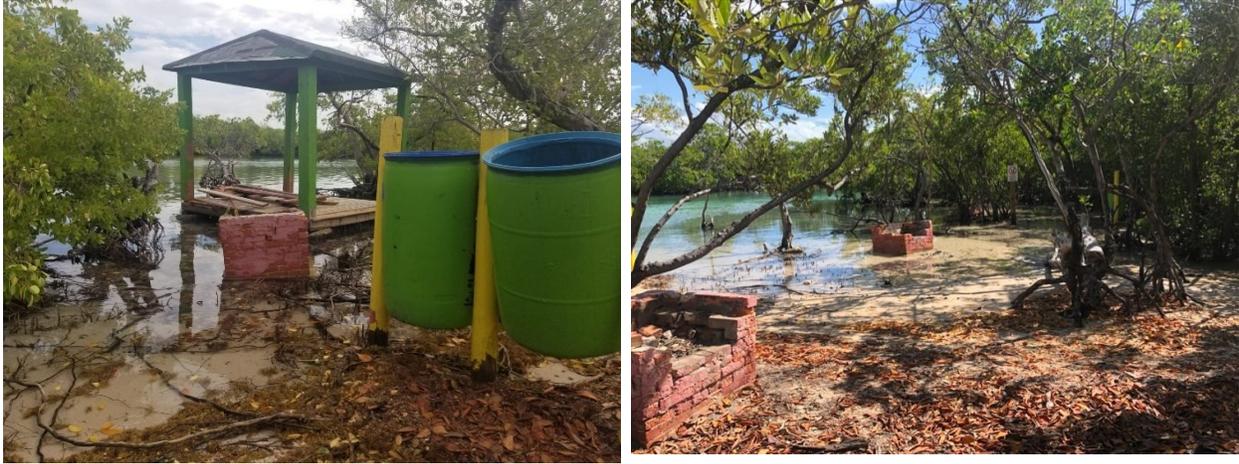
**Figure 4.** Damage to Cayo Aurora’s recreational structures after the beginning of the earthquake sequence in December 2019.

Dating back to 1983, the DNER implemented management strategies that provided recreational enjoyment with conservation of the cays, especially Cayo Aurora. These included a dock, various gazebos, charcoal burners, solid waste disposal sites, composting toilets, and a fishing platform. The public beach area was delineated, mooring buoys were installed, proper signaling was placed, and anchoring areas were designated. In conjunction with federal agencies (NOAA and the US Fish and Wildlife Service [USFWS]), various projects developed over the years including mangrove planting, restoration of seagrass beds, and an educational recreational fishing program. However, after the earthquake sequence that began in December 2019, structures within the cay were affected and deemed unsafe by the DNER. The DNER closed recreational areas due to severe

erosion on the cay (Figure 4). As of September 2022, PDC, along with DNER personnel, closed off the dock and removed the charcoal grills and restrooms to deter human use in the cay and allow the natural regeneration of the mangrove (Figure 5).

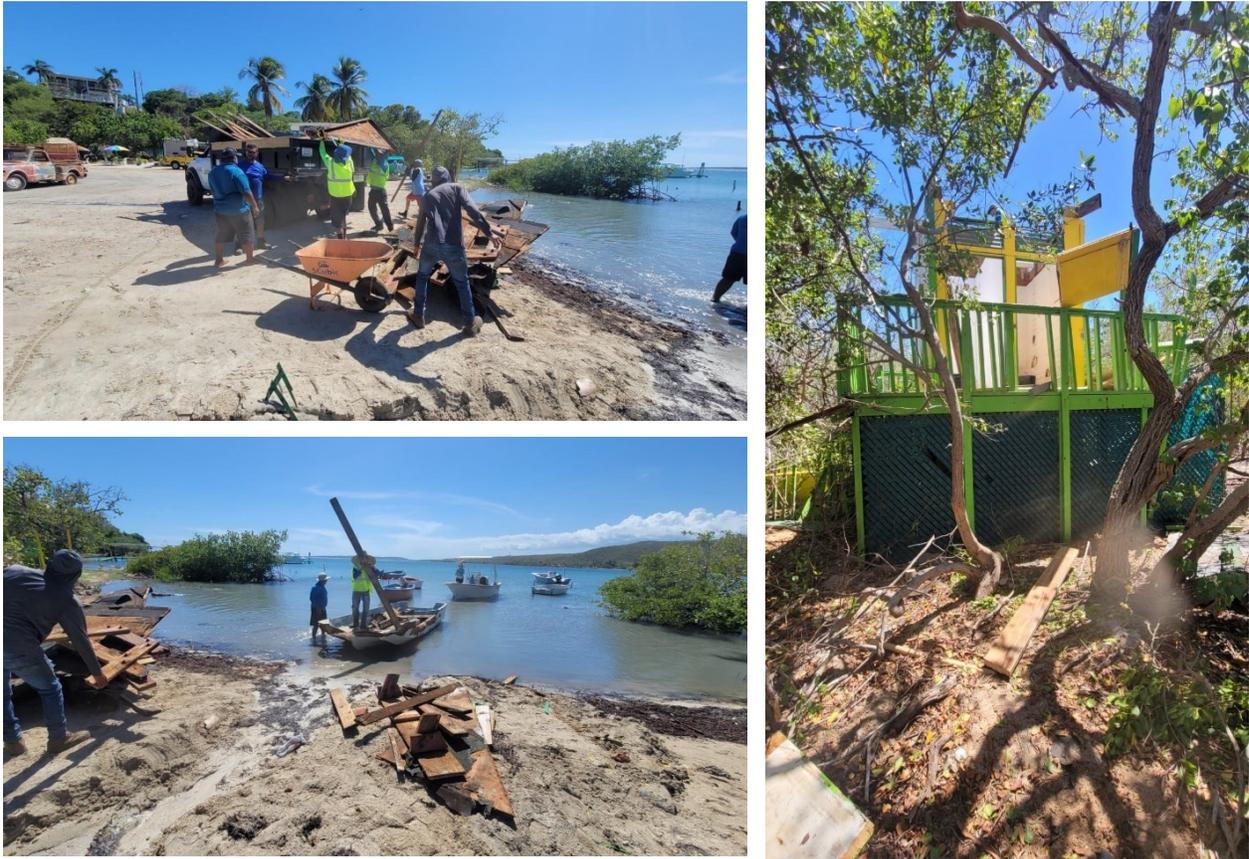
**Figure 5.** Recreational facilities at Cayo Aurora were removed after the 2019 earthquakes to discourage people from visiting the cay.

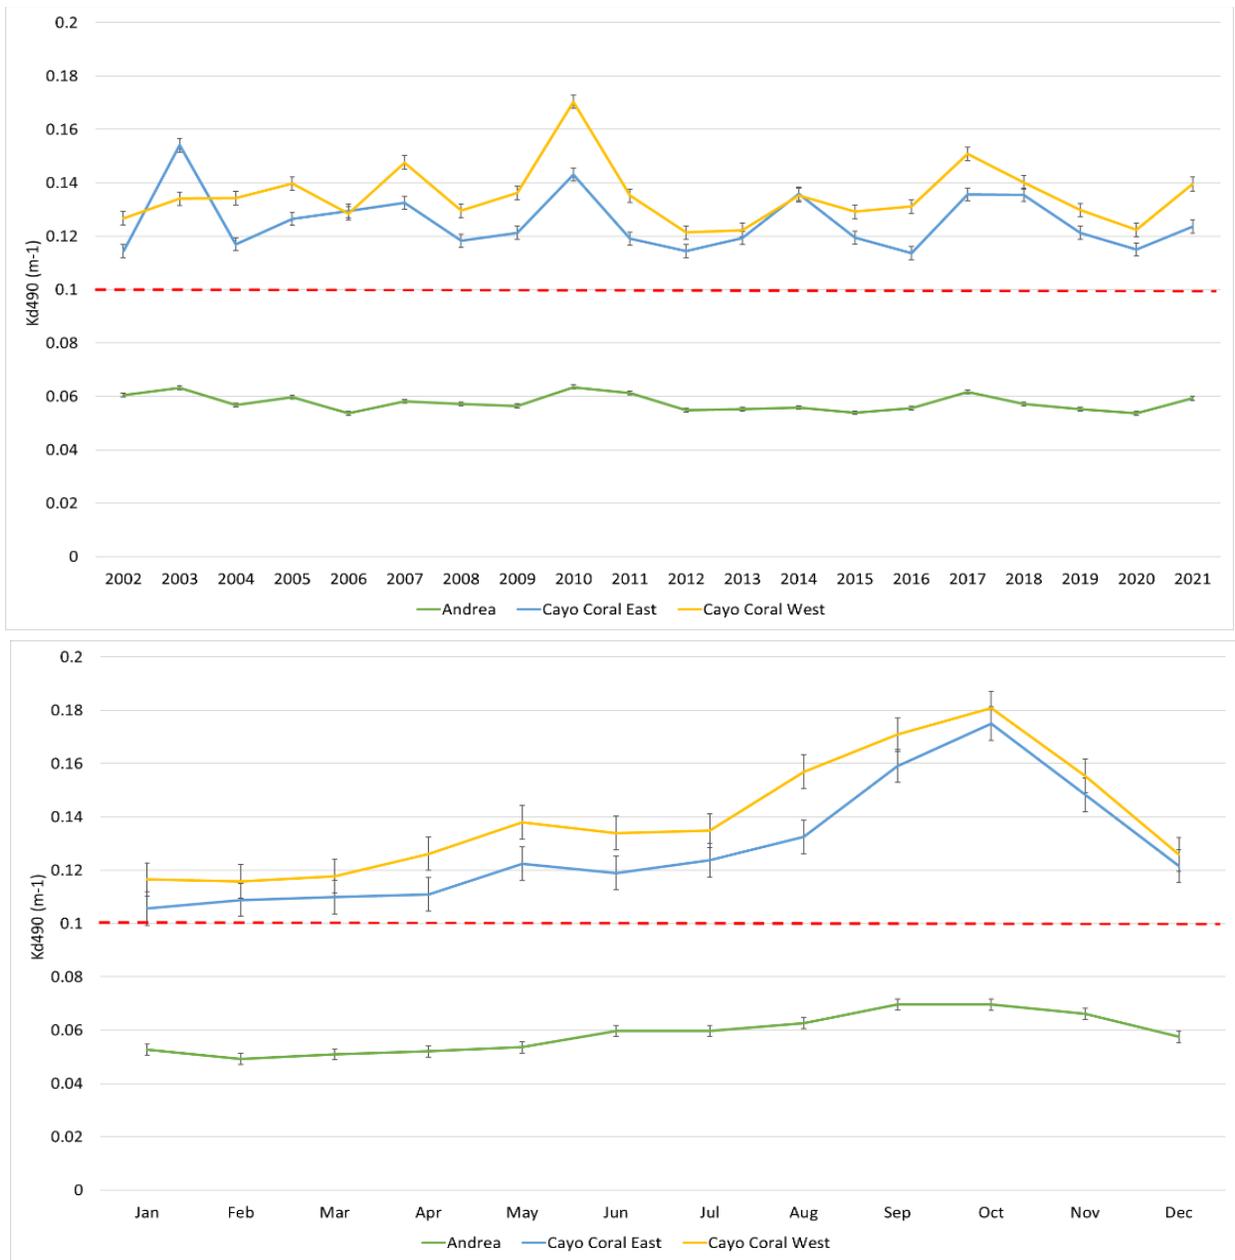
**Figure 26.** Yearly averages from 2002-2021 of  $K_d490$  values for Guánica region (top). Monthly averages from 2002-2021 of  $K_d490$  values for Guánica region (bottom). The threshold of 0.1 m<sup>-1</sup> (red-dashed line) is included for reference.

After analyzing the data, the Cayo Coral East and West showed an average value for  $K_d490$  that exceeded the 0.1 m<sup>-1</sup> threshold, while the Andrea site represented more oceanic values below this threshold (Figure 26).  $K_d490$  values above the 0.1m<sup>-1</sup> threshold are considered areas exposed to turbid water by other jurisdictions (e.g. Hawaii, Australia). Also, the Cayo Coral West site showed higher values when compared with Cayo Coral East site, which suggests the potential influence of the Guánica Bay plume track in the observed values. For the chlorophyll-a concentration, Cayo

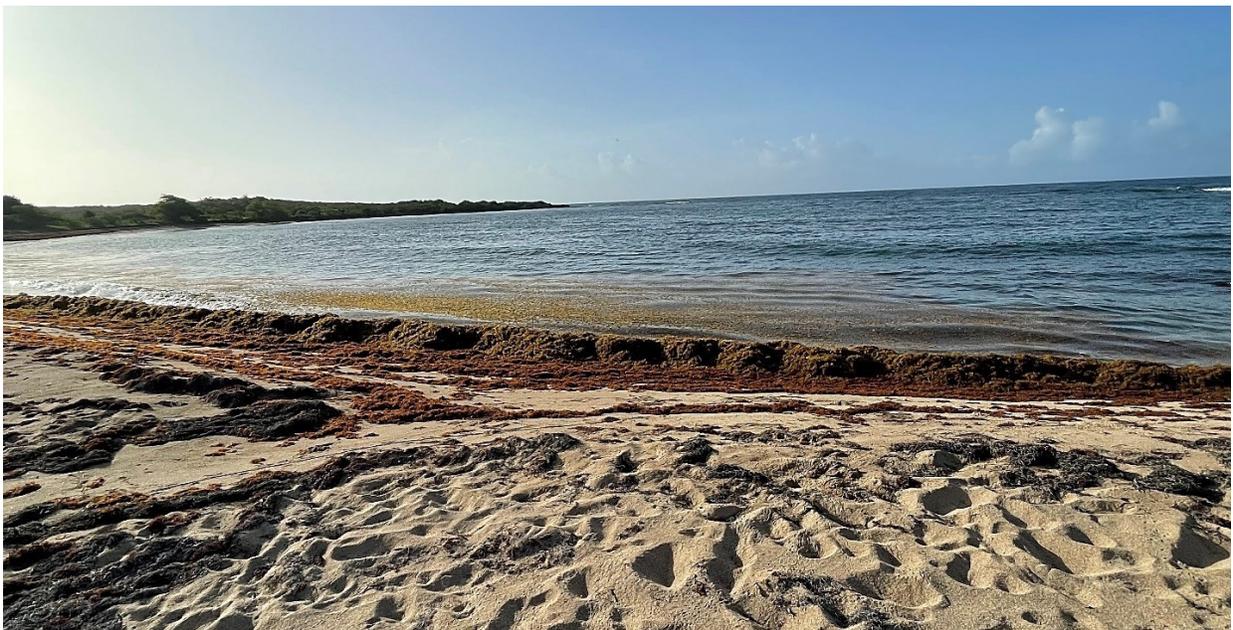
**Figure 29.** *Sargassum* accumulated in Playa Ballena during the summer of 2022.

In the Guánica Bay area, the large *sargassum* patches are carried by the surface currents and winds and from satellite and local observations accumulate primarily in the Las Pargas and Ballena areas (Figure 28). The accumulation at these locations persists throughout the *sargassum* season, limiting the use of these coastal resources in these areas and impacting the nearshore coastal and benthic communities. No long-term accumulation of *sargassum* has been documented in the Cayo Aurora area, however, even transient events can limit tourism and the use of the coastal resources in the area. Also, the effects of *sargassum* accumulation in Ballena and its decomposition products can reach Cayo Aurora with currently unknown consequences (Figure 29).

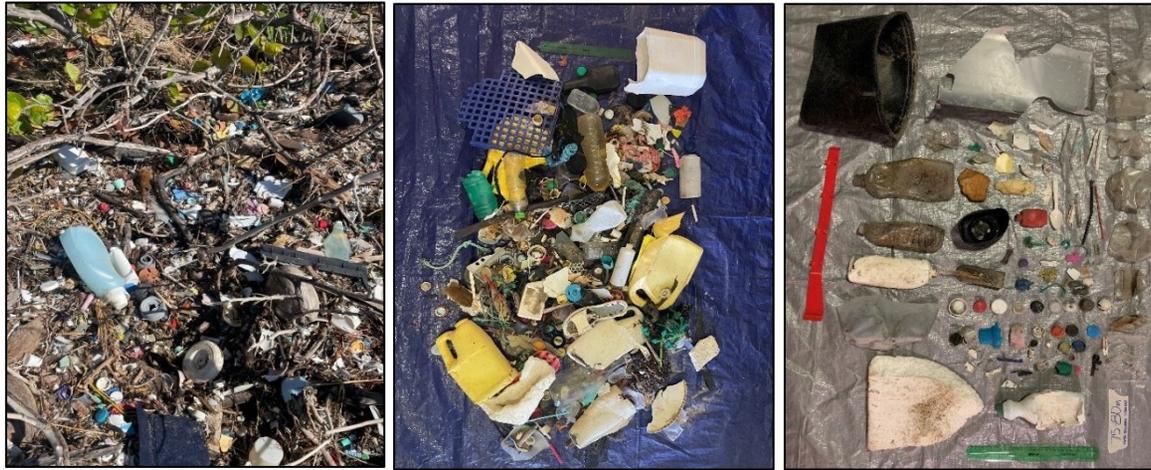
**Figure 31.** Photos of debris at Ballena Beach on October 8, 2022. The left photo shows debris accumulated on the beach. The middle and right photos are debris removed from transects on Ballena Beach for further characterization and laboratory degradation experiments. Photos from NOAA funded project *Assessment of Pathways and Degradation of Marine Debris within the Guánica Watershed and Surrounding Region of Southwest Puerto Rico*.

Marine debris characterizations and beach cleanups are conducted twice a year in Ballena Beach (Figure 31) and Las Pargas beach (Figure 32), once during the wet season and once during the dry season. Preliminary results coincide with data collected by Coe *et al.*, 1997. During the dry season, at Las Pargas Beach, more than 23% of marine debris collected was related to fishing practices. Plastic was also the principal type of marine debris observed in all the study sites (Figure 33). Although Las Pargas is not part of the ME, this beach is close to the ME and marine debris originating from this area can influence marine life in the area.

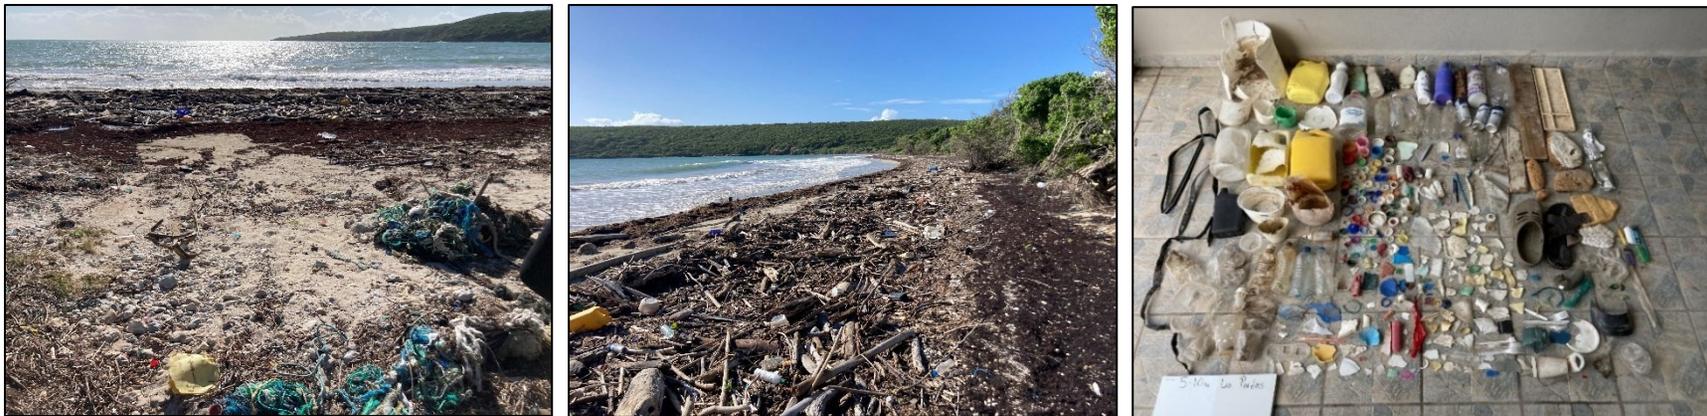
**Figure 32.** Photos of Las Paldas beach (left and middle) and a subset of the debris removed and characterized (right) on November 26, 2022. Photos from NOAA funded project *Assessment of Pathways and Degradation of Marine Debris within the Guánica Watershed and Surrounding Region of Southwest Puerto Rico*.

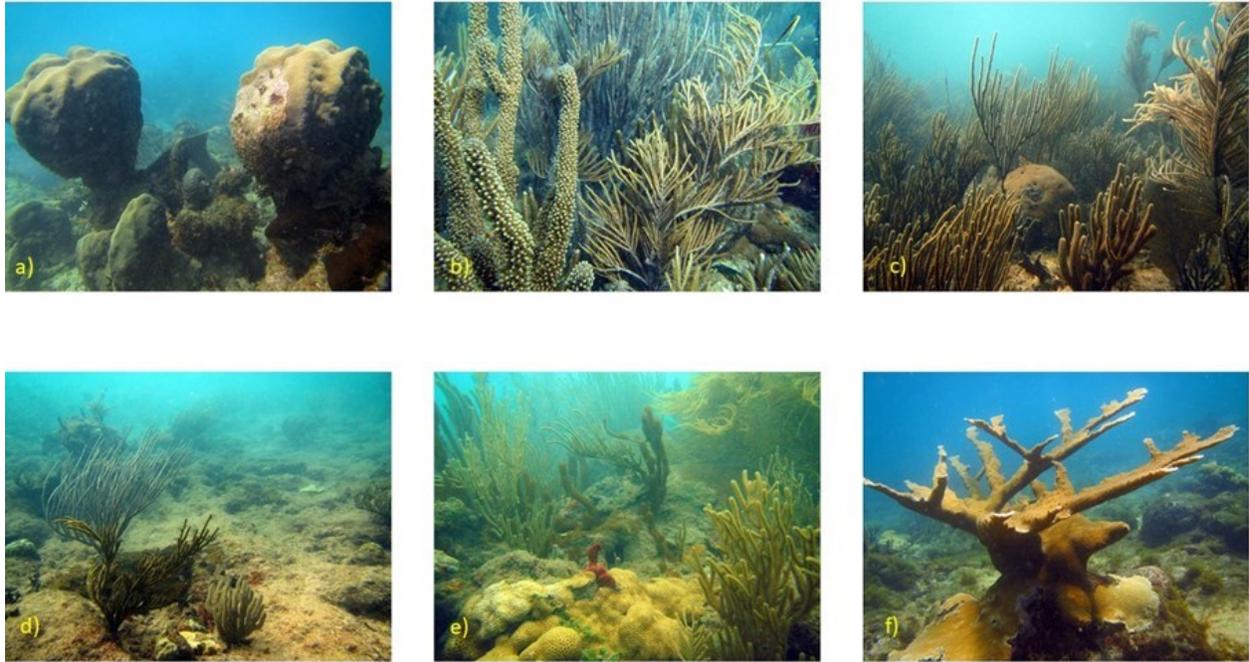
**Figure 35.** Typical benthic components of reefs associated with the Guánica watershed. a) *Orbicella faveolata* colonies; b, c, e) gorgonian plains; d) hardbottom with sparse Scleractinian and gorgonian colonies; f) *Acropora palmata* colony. Photo credit Dr. Juan Torres-Pérez.

A study conducted by PDC and sponsored by the NOAA Coral Reef Conservation Program, entitled *Benthic community structure characterization and assessment of turbidity impacts of the north (Manatí and Vega Baja) and south (Guánica) coasts, Puerto Rico*, involved conducting a benthic characterization of various sites in 2018. The sites of Corona La Laja and Punta Pescadores were included as part of this study and video transects were collected to estimate coral, submerged aquatic vegetation, and benthic substrate types. The site for Corona La Laja south is a submerged key south of Guánica Bay which is partially included in the current GSF ME. This site was mainly dominated by sand, hardbottom with algae, pavement, and rubble but included approximately 8% of hard coral cover and close to 35% of soft corals (octocorals). The site of Punta Pescadores is located west of the Guánica Bay entrance, and it is currently not included in the GSF ME. This site was also mainly dominated by sand, bottom with algae, pavement, and rubble but included approximately 10% of hard coral cover and close to 40% of soft corals (octocorals). The observations show a dominance of gorgonian plains in most reefs in Guánica, at least at the sampled depths (4-10m). Reef zones that usually receive higher wave action are dominated by hardbottom with sparse colonies of the threatened *Acropora palmata* and *A. cervicornis* along with small colonies of other important reef-builders (*Orbicella annularis*, *O. faveolata*, *Pseudodiploria strigosa*, *P. clivosa*, and *Montastraea cavernosa*) (Figure 35).

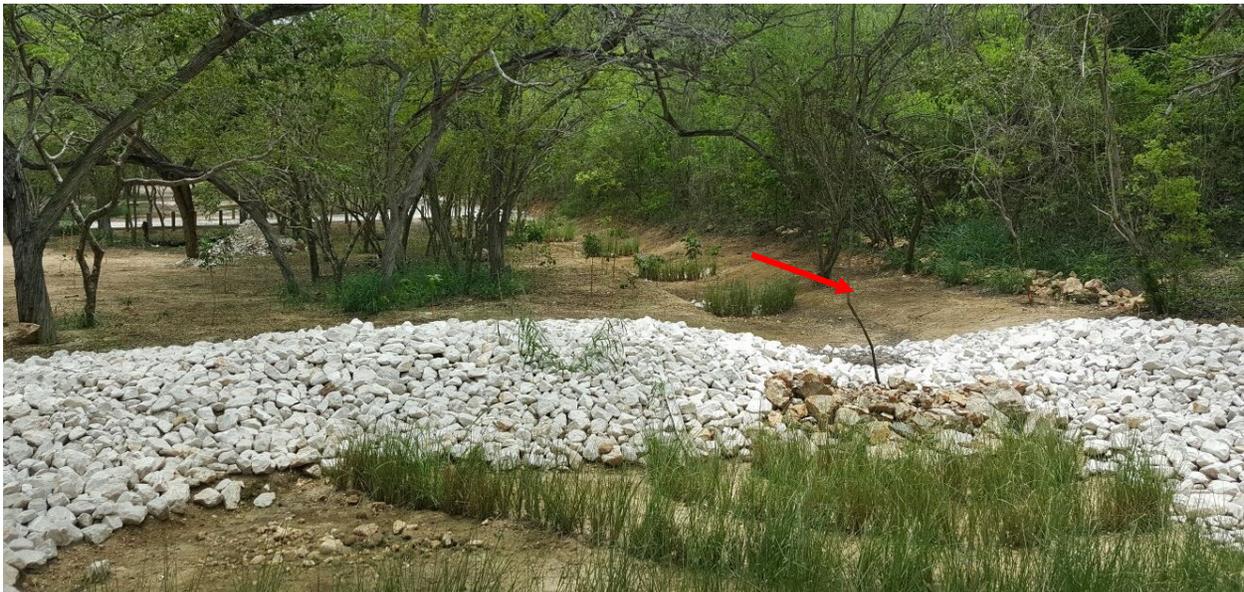
**Figure 40.** Example of a rain garden prepared by PDC personnel at Jaboncillo Beach, Guánica. The red arrow indicates the influx of water following a rain event. Water passes through the vegetation where it reduces its speed while nutrients and sediments are retained.

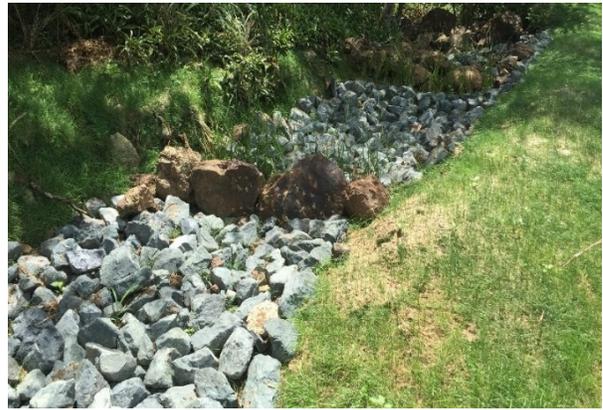
**Figure 42.** Example of a vegetated swale prepared by PDC personnel at Fulladosa, Culebra. In this design rocks were used along with the vegetation to create a channel.

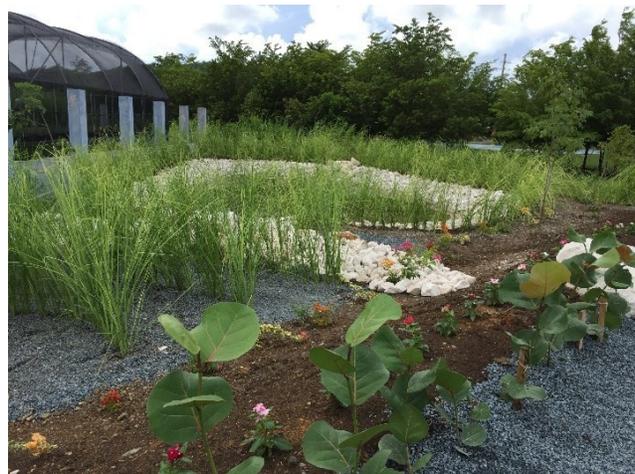
**Figure 43.** Example of a vegetated filter strip prepared by PDC personnel at the facilities of PDC in Yauco, PR. This strip helps to redirect and filter rainwater before arriving at the nearby river.

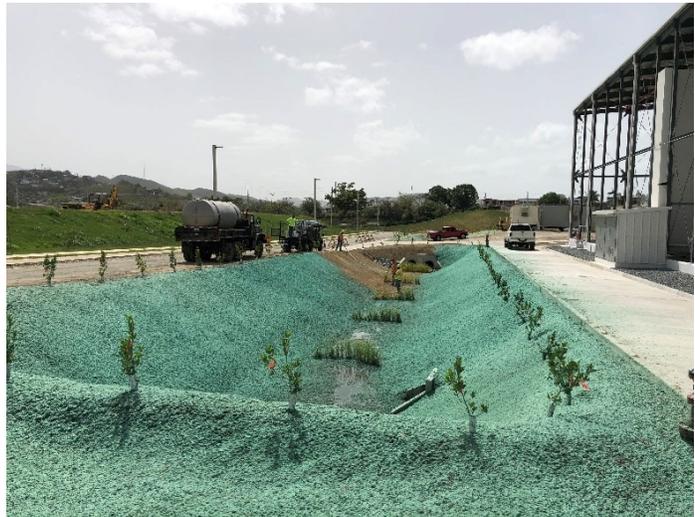
**Figure 46.** Example of hydroseeding application by PDC personnel at the facilities of Sartorius in Yauco, PR.

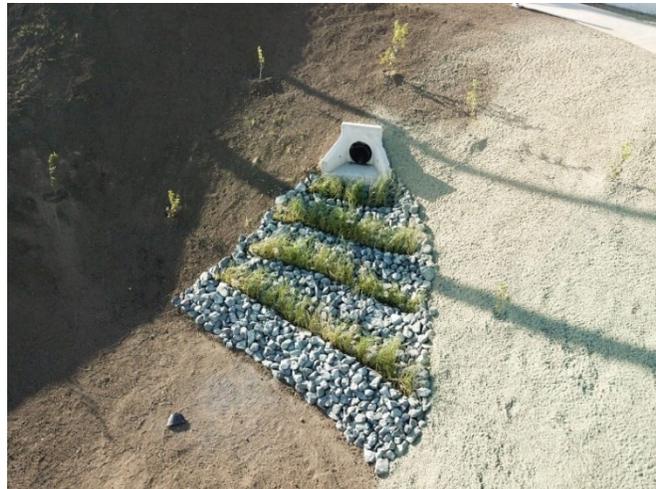
**Figure 47.** Example of a sediment trap technique implemented by PDC personnel at the facilities of Sartorius in Yauco, PR.

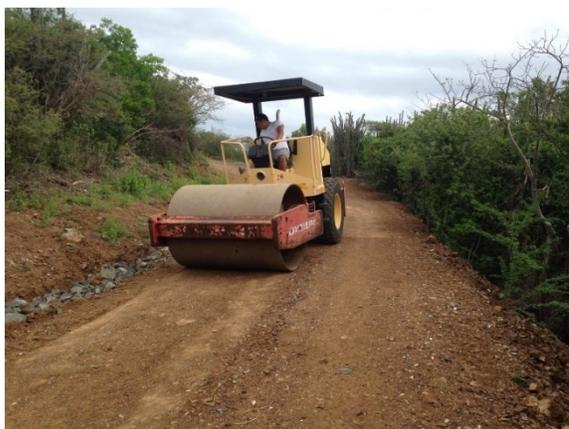
**Figure 48.** Example of dirt road stabilization techniques in Punta Soldado, Culebra, PR.

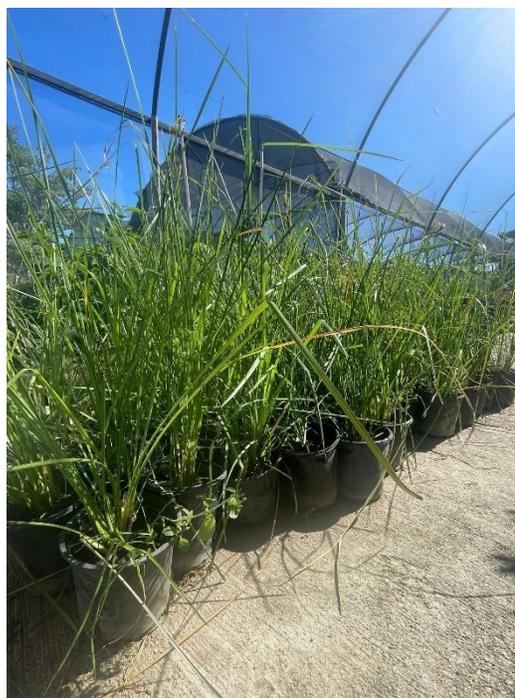
- C. Vetiver grass: the use of this grass is a very simple, practical, inexpensive, low maintenance and effective means of soil and water conservation, sediment control, land stabilizations and rehabilitation. When planted in a linear pattern or in half-moons, vetiver plants will form a vegetative mass which is highly effective in slowing and spreading run off water, reducing soil erosion, conserving soil moisture, and trapping sediment on site. The extremely deep and massively thick root system of Vetiver binds the soil and at the same time makes it difficult for it to be displaced under high velocity water flows. It is a very deep and fast-growing plant that can also tolerate extreme drought conditions as well as moderate soil salinity concentrations with a highly effectiveness on steep slope stabilization. The most commonly available Vetiver plant material comes in small plots, but the best and more rapid results are achieved when plots are transplanted to a 1-gallon pot and grown for no less than 3 months. With this technique, planted

**Figure 49.** Vetiver grass in PDC's nursery in Yauco, PR.

Vetiver grass, responds more rapidly, and adapts to the site's climate conditions more efficiently and with less maintenance (Figure 49).

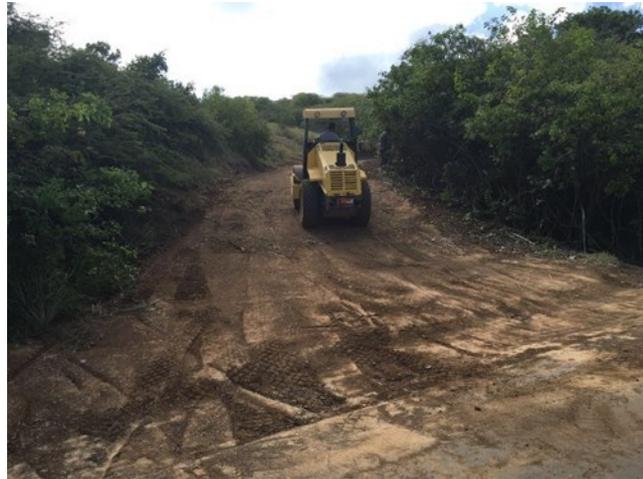
**Figure 50.** Example of regrading by PDC on a dirt road in Culebra, Puerto Rico.

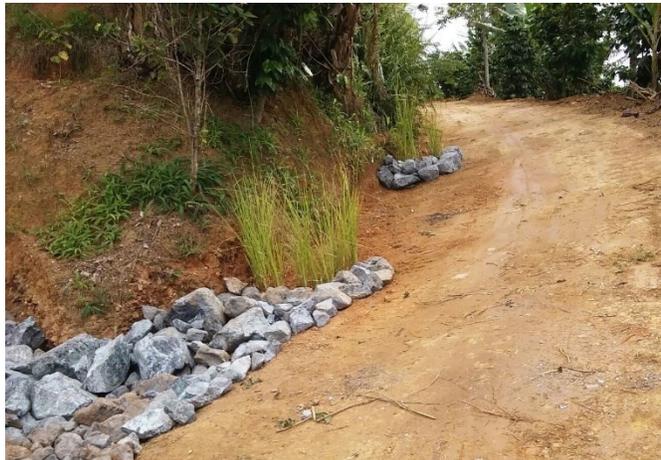
**Figure 51.** Example of check dams constructed by PDC on a dirt road network in Hacienda Candelaria located on the coffee region of Yauco Puerto Rico.
